INFORMATION UPDATE ON PHASE 2 OF THE EX POST PROJECT SUSTAINABILITY EVALUATIONS

TECHNICAL EVALUATION REFERENCE GROUP OF THE ADAPTATION FUND (AF-TERG)

"Enhancing Resilience of Samoa's Coastal Communities to Climate Change"

"Enhancing Resilience of Communities to the Diverse Effects of Climate Change on Food Security in the Pichincha Province and the Jubones River Basin of Ecuador, FORECCSA"

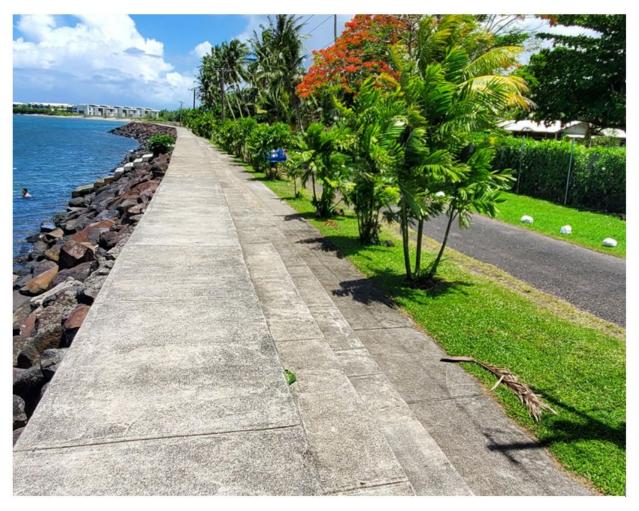
Structure protecting houses and road from the sea funded by the Adaptation Fund. Vaiala, Samoa, 2022

In the 2018 Community Integrated Management (CIM) Plans for Vaimauga West, the Vaiala seawall was deemed "in very good condition". It was also reported to have "improved the scenery" along the Vaiala coast. Field observations showed no visible defects on the seawall. The structure continues to provide adequate coastal protection for surrounding natural and human systems. There was no structural damage following recent climate disturbances, and the seawall has become a key recreational feature in the Apia urban area.

The Vaiala seawall demonstrates the most indications of clear sustainability i.e. it has no visible defects and a clean structure. High ownership could be observed in the villages. Routine lawn maintenance by the Land Transport Authority (LTA) is augmented by Ministry of Natural Resources, Environment and Meteorology contractors through waste management and rubbish collection.

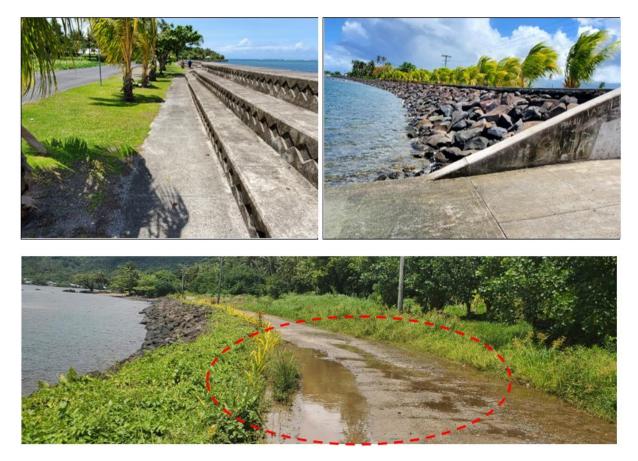
Figure 1. Examples of sustained and unsustained structures

Infrastructure site 3: Vaiala seawall - no visible defects (landside view, left; seaside view, right)

Infrastructure site 4: Salimu/ Musumusu rockwall – rocks are crumbling into wetlands and water is collecting on the road

The Salimu/Musumusu road is a 2.2 km stretch, protected by a 1 km rockwall, that aims to protect village properties from coastal erosion and flooding. Field observations have shown some signs of destabilization on sections of Salimu/Musumusu rockwall. Wetland and stream water run-off flows onto the road and there are weeds along the shoulder. In addition, there is no parallel drainage to guide wetland and stream run-off to cross culverts, and ponds on the road. Despite the road condition and the need for maintenance to improve drainage of wetland and stream overflow, neither the LTA nor the villages have tried to make repairs.

The road will likely continue deteriorating. Furthermore, rising sea levels will undermine capacities and limits of infrastructure along the coastline. There is merit in considering the CIM Plan that proposes relocation of key infrastructure and village farther inland, away from coastal and flood erosion hazard areas.

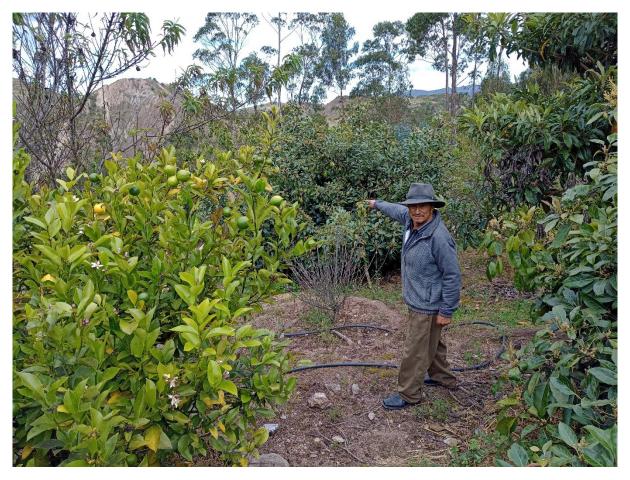
An orchard funded by the Adaptation Fund. Nabón, Ecuador, 2022

In Cochapata, FORECCSA orchards assisted 54 families. At ex post, the lands visited with the communities through transect walk had been maintained. Families were both consuming and selling the fruit, although few knew for how much it could be sold. For the interviewees, selling products was not a priority. The production cost had become too high for them because of elements such as fertilizer. Contrary to Nabón, Cochapata did not experience large outmigration.
