**AFB/EFC.30/Inf.3 - Annex I**

September 2022

## Ex Post Evaluation Summary - Samoa

# Enhancing Resilience of Samoa's Coastal Communities to Climate Change

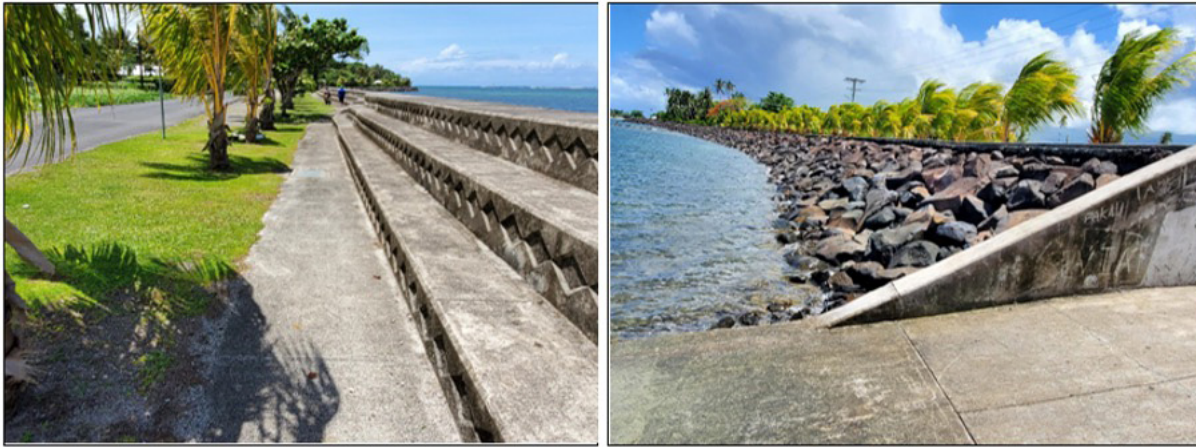
**FIGURE 1: Examples of sustained and unsustained structures**

Infrastructure site 3: Vaiala seawall – no visible defects (landside view, left; seaside view, right)

Vaiala seawall was completed in 2015 to protect against tidal tides and storm surges. Its design allowed for utility services (e.g. electric power lines), which were previously located on the coastline, and for a cement pedestrian footpath both at its crest and base.

In the 2018 Community Integrated Management (CIM) Plans for Vaimauga West, the Vaiala seawall was deemed “in very good condition”. It was also reported to have “improved the scenery” along the Vaiala coast. Field observations showed no visible defects on the seawall. The structure continues to provide adequate coastal protection for surrounding natural and human systems. There was no structural damage following recent climate disturbances, and the seawall has become a key recreational feature in the Apia urban area.

The Vaiala seawall demonstrates the most indications of clear sustainability i.e. it has no visible defects and a clean structure. High ownership could be observed in the villages. Routine lawn maintenance by the Land Transport Authority (LTA) is augmented by Ministry of Natural Resources, Environment and Meteorology contractors through waste management and rubbish collection.

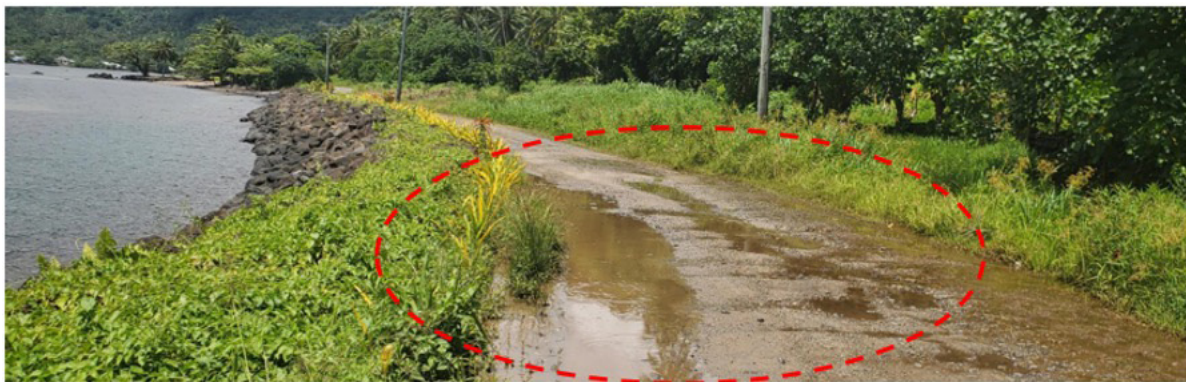
Infrastructure site 4: Salimu/ Musumusu rockwall – rocks are crumbling into wetlands and water is collecting on the road

The Salimu/Musumusu road is a 2.2 km stretch, protected by a 1 km rockwall, that aims to protect village properties from coastal erosion and flooding. Field observations have shown some signs of destabilization on sections of Salimu/Musumusu rockwall. Wetland and stream water run-off flows onto the road and there are weeds along the shoulder. In addition, there is no parallel drainage to guide wetland and stream run-off to cross culverts, and ponds on the road. Despite the road condition and the need for maintenance to improve drainage of wetland and stream overflow, neither the LTA nor the villages have tried to make repairs.

The road will likely continue deteriorating. Furthermore, rising sea levels will undermine capacities and limits of infrastructure along the coastline. There is merit in considering the CIM Plan that proposes relocation of key infrastructure and village farther inland, away from coastal and flood erosion hazard areas.
