AFB/EFC.30/Inf.3 - Annex I

Ex Post Evaluation Summary - Samoa

Enhancing Resilience of Samoa's Coastal Communities to Climate Change

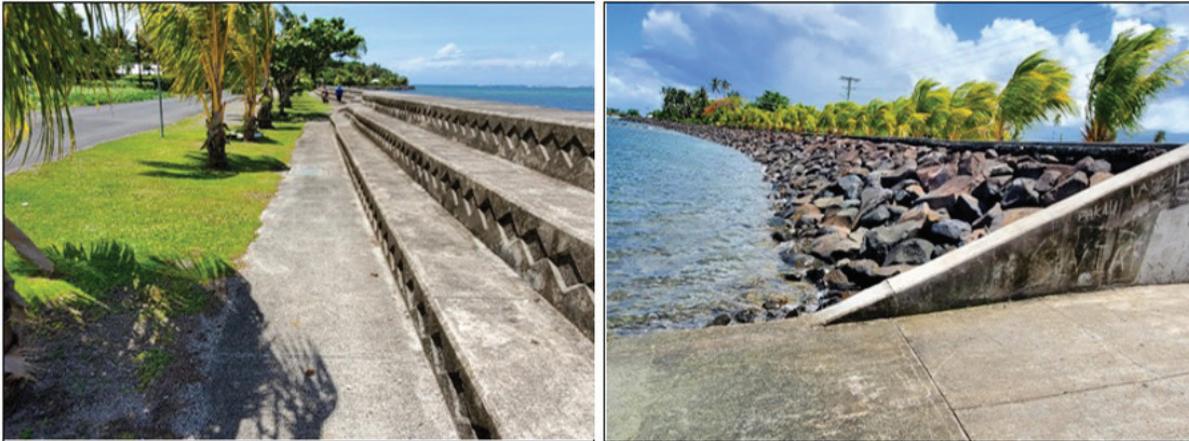
FIGURE 1: Examples of sustained and unsustained structures

Infrastructure site 3: Vaiala seawall – no visible defects (landside view, left; seaside view, right)

Vaiala seawall was completed in 2015 to protect against tidal tides and storm surges. Its design allowed for utility services (e.g. electric power lines), which were previously located on the coastline, and for a cement pedestrian footpath both at its crest and base.

In the 2018 Community Integrated Management (CIM) Plans for Vaimauga West, the Vaiala seawall was deemed “in very good condition”. It was also reported to have “improved the scenery” along the Vaiala coast. Field observations showed no visible defects on the seawall. The structure continues to provide adequate coastal protection for surrounding natural and human systems. There was no structural damage following recent climate disturbances, and the seawall has become a key recreational feature in the Apia urban area.

The Vaiala seawall demonstrates the most indications of clear sustainability i.e. it has no visible defects and a clean structure. High ownership could be observed in the villages. Routine lawn maintenance by the Land Transport Authority (LTA) is augmented by Ministry of Natural Resources, Environment and Meteorology contractors through waste management and rubbish collection.

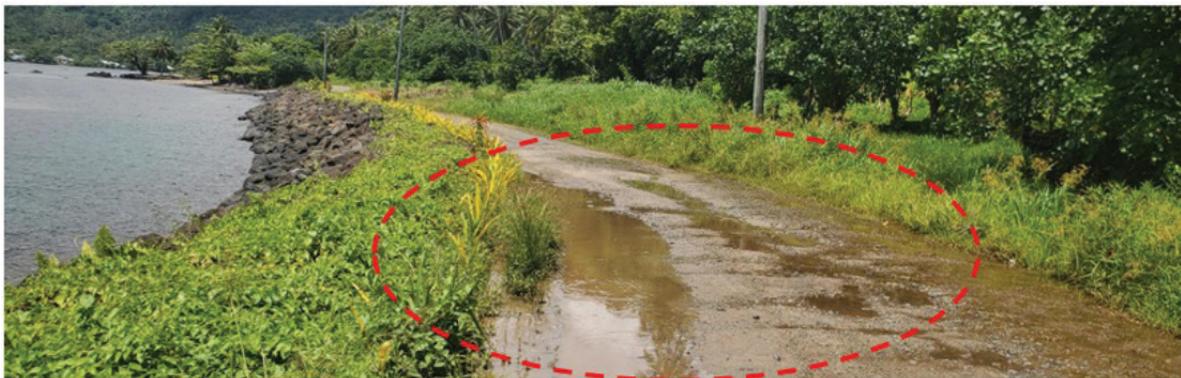
Infrastructure site 4: Salimu/ Musumusu rockwall – rocks are crumbling into wetlands and water is collecting on the road

The Salimu/Musumusu road is a 2.2 km stretch, protected by a 1 km rockwall, that aims to protect village properties from coastal erosion and flooding. Field observations have shown some signs of destabilization on sections of Salimu/Musumusu rockwall. Wetland and stream water run-off flows onto the road and there are weeds along the shoulder. In addition, there is no parallel drainage to guide wetland and stream run-off to cross culverts, and ponds on the road. Despite the road condition and the need for maintenance to improve drainage of wetland and stream overflow, neither the LTA nor the villages have tried to make repairs.

The road will likely continue deteriorating. Furthermore, rising sea levels will undermine capacities and limits of infrastructure along the coastline. There is merit in considering the CIM Plan that proposes relocation of key infrastructure and village farther inland, away from coastal and flood erosion hazard areas.
