**AFB/EFC.30/Inf.3 - Annex I**

## Ex Post Evaluation Summary - Samoa

# Enhancing Resilience of Samoa's Coastal Communities to Climate Change

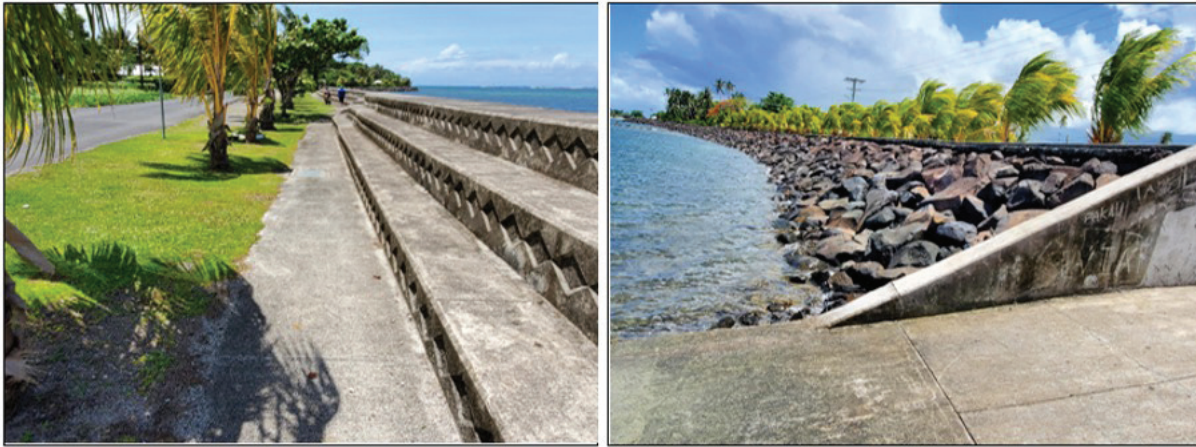
**FIGURE 1: Examples of sustained and unsustained structures**

In the 2018 Community Integrated Management (CIM) Plans for Vaimauga West, the Vaiala seawall was deemed “in very good condition”. It was also reported to have “improved the scenery” along the Vaiala coast. Field observations showed no visible defects on the seawall. The structure continues to provide adequate coastal protection for surrounding natural and human systems. There was no structural damage following recent climate disturbances, and the seawall has become a key recreational feature in the Apia urban area.

The Vaiala seawall demonstrates the most indications of clear sustainability i.e. it has no visible defects and a clean structure. High ownership could be observed in the villages. Routine lawn maintenance by the Land Transport Authority (LTA) is augmented by Ministry of Natural Resources, Environment and Meteorology contractors through waste management and rubbish collection.

Infrastructure site 3: Vaiala seawall – no visible defects (landside view, left; seaside view, right)

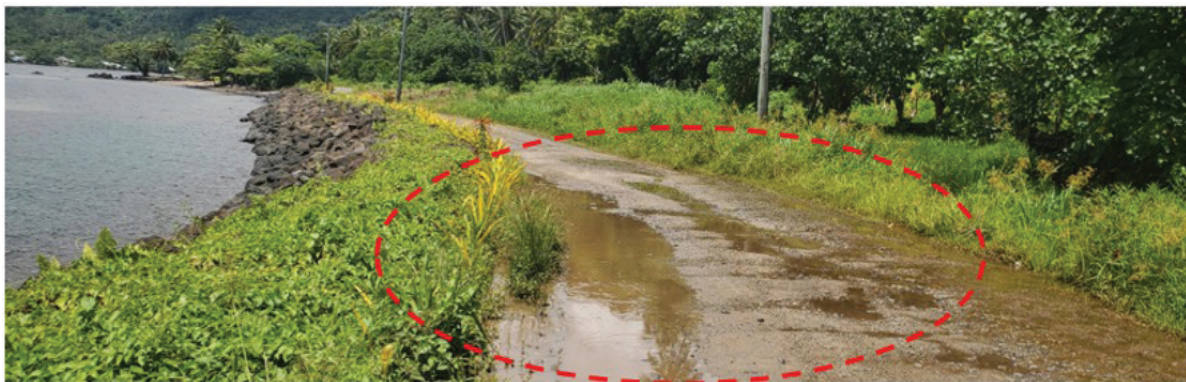
The Salimu/Musumusu road is a 2.2 km stretch, protected by a 1 km rockwall, that aims to protect village properties from coastal erosion and flooding. Field observations have shown some signs of destabilization on sections of Salimu/Musumusu rockwall. Wetland and stream water run-off flows onto the road and there are weeds along the shoulder. In addition, there is no parallel drainage to guide wetland and stream run-off to cross culverts, and ponds on the road. Despite the road condition and the need for maintenance to improve drainage of wetland and stream overflow, neither the LTA nor the villages have tried to make repairs.

The road will likely continue deteriorating. Furthermore, rising sea levels will undermine capacities and limits of infrastructure along the coastline. There is merit in considering the CIM Plan that proposes relocation of key infrastructure and village farther inland, away from coastal and flood erosion hazard areas.

Infrastructure site 4: Salimu/ Musumusu rockwall – rocks are crumbling into wetlands and water is collecting on the road
