**AFB/EFC.30/Inf.3 - Annex I**

September 2022

## Ex Post Evaluation Summary - Samoa

# Enhancing Resilience of Samoa's Coastal Communities to Climate Change

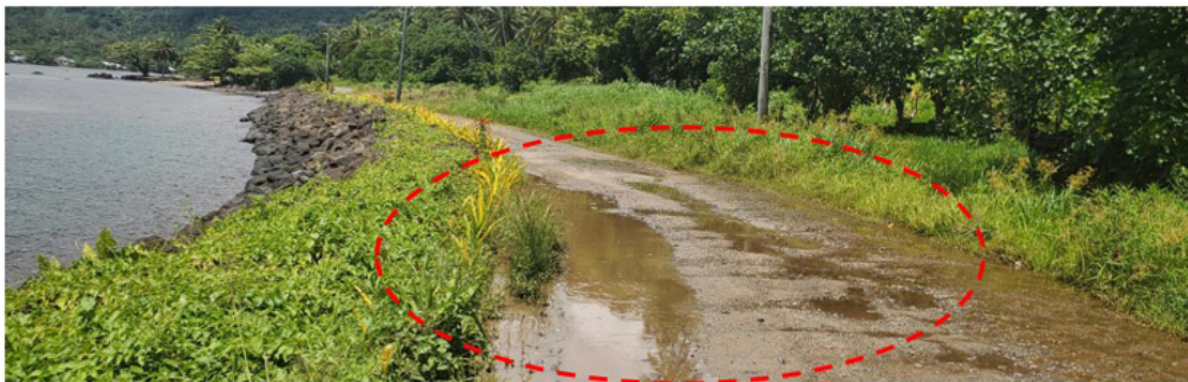
The Salimu/Musumusu road is a 2.2 km stretch, protected by a 1 km rockwall, that aims to protect village properties from coastal erosion and flooding. Field observations have shown some signs of destabilization on sections of Salimu/Musumusu rockwall. Wetland and stream water run-off flows onto the road and there are weeds along the shoulder. In addition, there is no parallel drainage to guide wetland and stream run-off to cross culverts, and ponds on the road. Despite the road condition and the need for maintenance to improve drainage of wetland and stream overflow, neither the LTA nor the villages have tried to make repairs.

The road will likely continue deteriorating. Furthermore, rising sea levels will undermine capacities and limits of infrastructure along the coastline. There is merit in considering the CIM Plan that proposes relocation of key infrastructure and village farther inland, away from coastal and flood erosion hazard areas.

Infrastructure site 4: Salimu/ Musumusu rockwall – rocks are crumbling into wetlands and water is collecting on the road
