Ex Post Evaluation Summary - Ecuador

Enhancing Resilience of Communities to the Diverse Effects of Climate Change on Food Security in the Pichincha Province and the Jubones River Basin of Ecuador

**Technical Evaluation
Reference Group**
ADAPTATION FUND

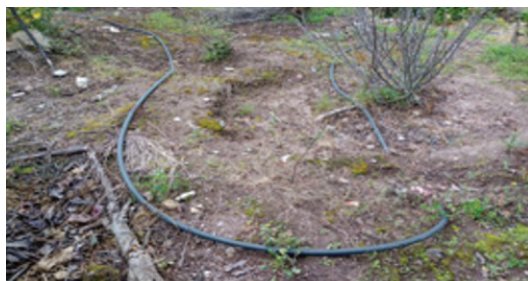
FIGURE 2: Abandoned garden with piping, Nabón

In Nabón, FORECCSA constructed 1.30 km of private water lines and provided pumping systems to landowners, which enabled them to connect to public water channels. At ex post, nearly half of beneficiaries in Nabón did not have access to piped water anymore because a landslide in December 2021 had destroyed the neighbourhood of Las Rosas and blocked La Laguna — the public water channel. This forced people to return to a traditional water source, the Chalcay River, if they were living in its vicinity. They used new pumps and pipes provided by the FORECCSA project or purchased them anew when they wore out. Those living far from the river depended on rain only for their crops and orchards. All four respondents praised water piping where it was still available. Nonetheless, none changed their cultivation or climate-resilience cropping to address the droughts or decreased water supply.

In Nabón, FORECCSA also provided fruit trees (peach, pear, and avocado) and horticultural species. This allowed 105 families to have their own orchards in the Casal Bajo La Laguna neighborhood. At ex post, most lands, and consequently orchards, had been abandoned. Due to the economic crisis and the pandemic, the city experienced an intense wave of migration towards mines, cities, and other countries. Nabón became a “ghost town.” Where people stayed, a few orchards were working. All four people interviewed consumed or gifted the avocados, peaches, and vegetables to friends and families as social capital, but none sold them to the market. Tellingly, the abandoned farms’ fruits and vegetables were left to rot without being gathered by anyone for the migrants’ return or sale during their migration.

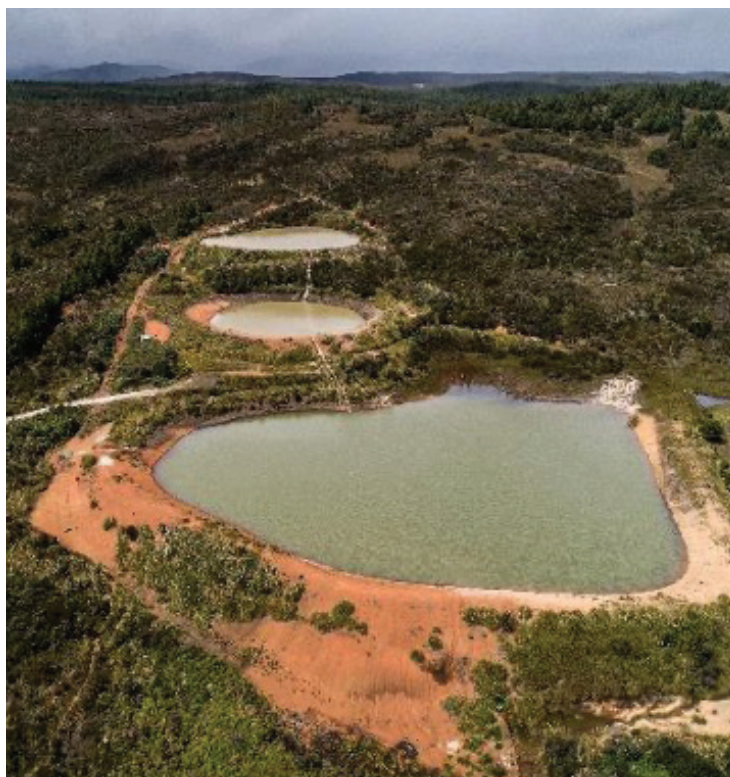
FIGURE 3: Rehabilitated reservoirs in Cochapata

In Cochapata, FORECCSA rehabilitated a long-abandoned system of three communal reservoirs. This made it the most sizeable investment visited out of the evaluated sites, as well as the most successful. The respondents are relying on reservoirs for all their irrigation needs; before the project, they relied on rainwater. Nearly all (93 per cent) also used water from the reservoirs to cultivate their orchards and gardens. The infrastructure consists of three reservoirs supplied with two public water channels (Shinkata and Culebrillas). They are connected with reinforced pipelines and a pressure pumps net. At ex post, the system had been maintained through biannual communal work performed by the families. The population used it widely for their agriculture needs.
